UTAH'S FLOOD PROBLEM

A Report to

UTAH STATE LAND BOARD

L. M. WINSOR  
Irrigation Engineer  
Bureau of Agricultural Engineering  
United States Department of Agriculture.

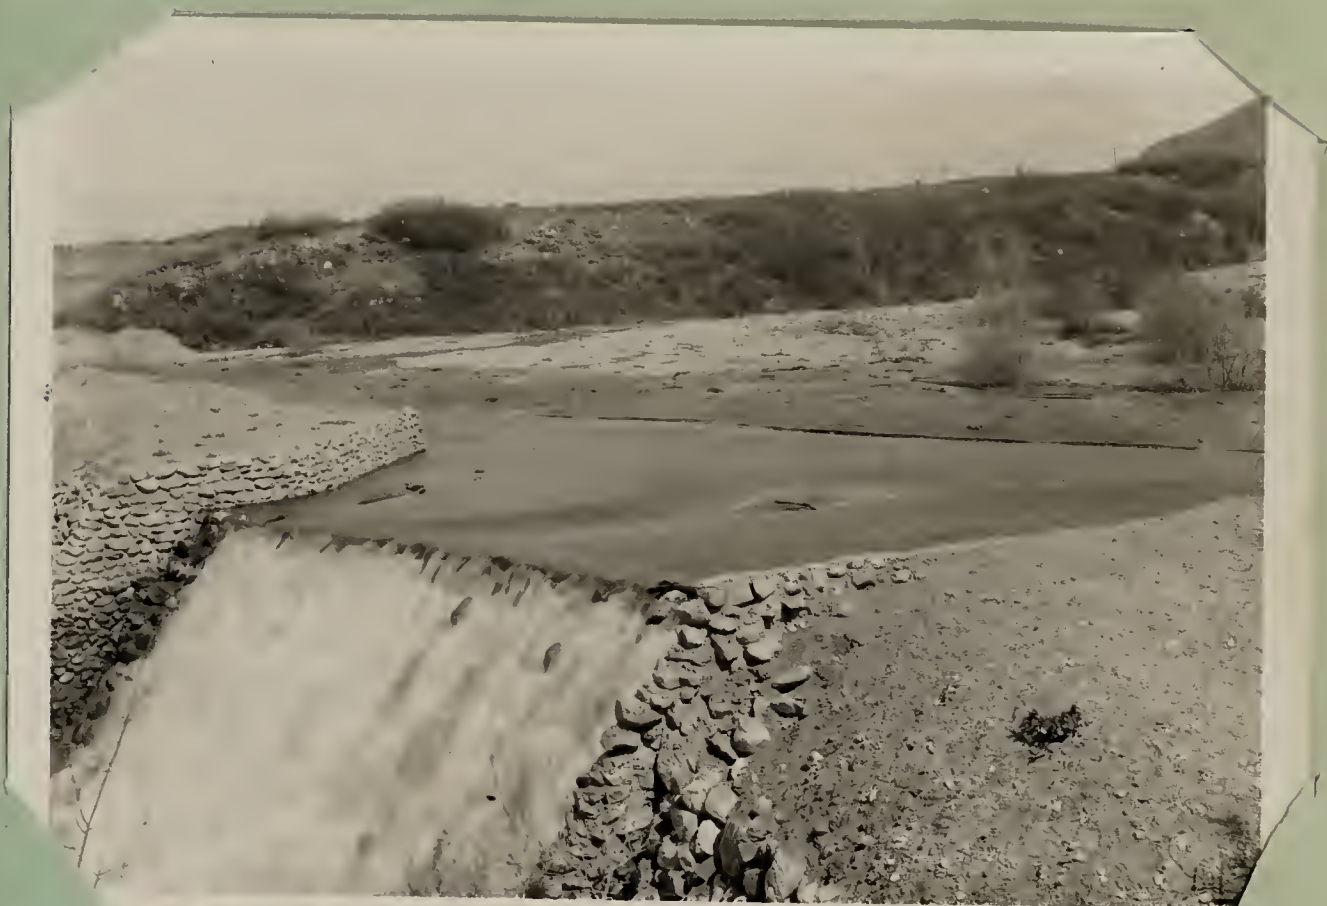
Farmington Spillway ready for receiving  
1932 flood stream.

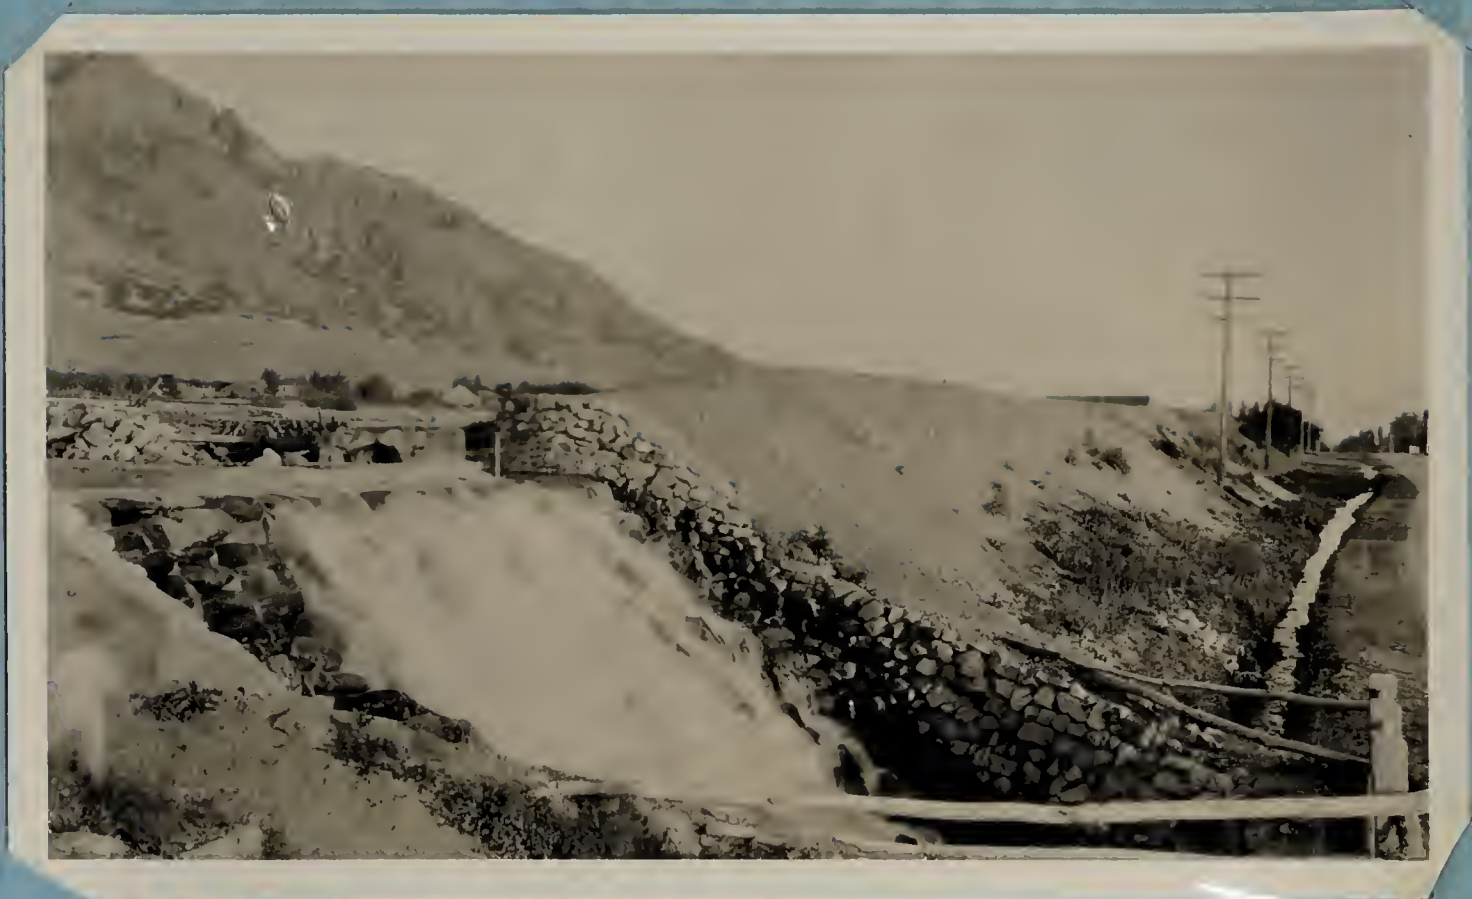
Willard Barrier at the close of the second  
high water season following control, (June 1926)

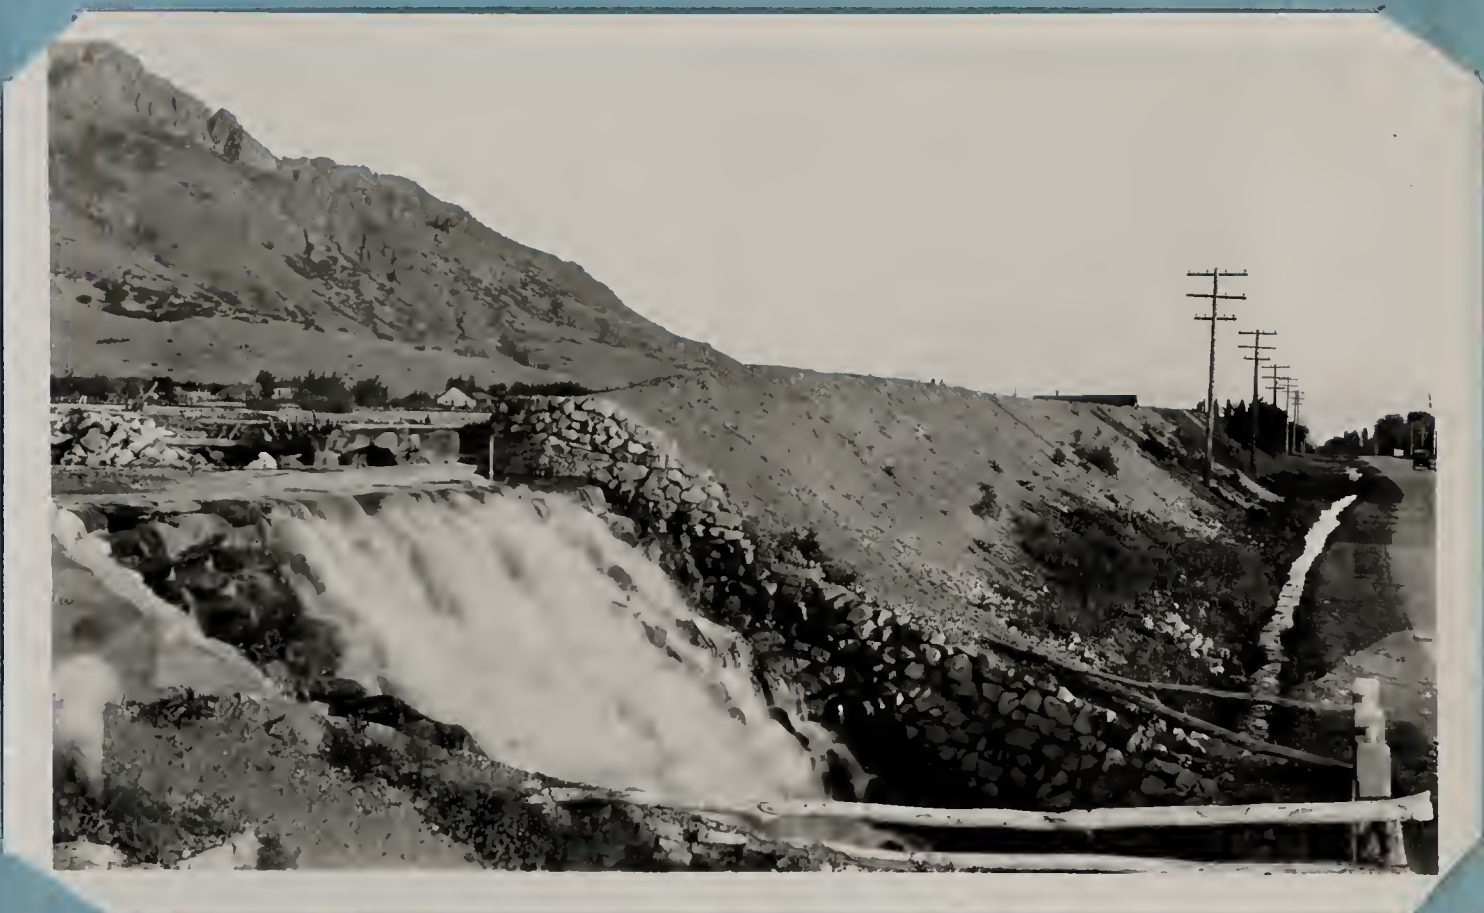
A close up of the spillway, same date.

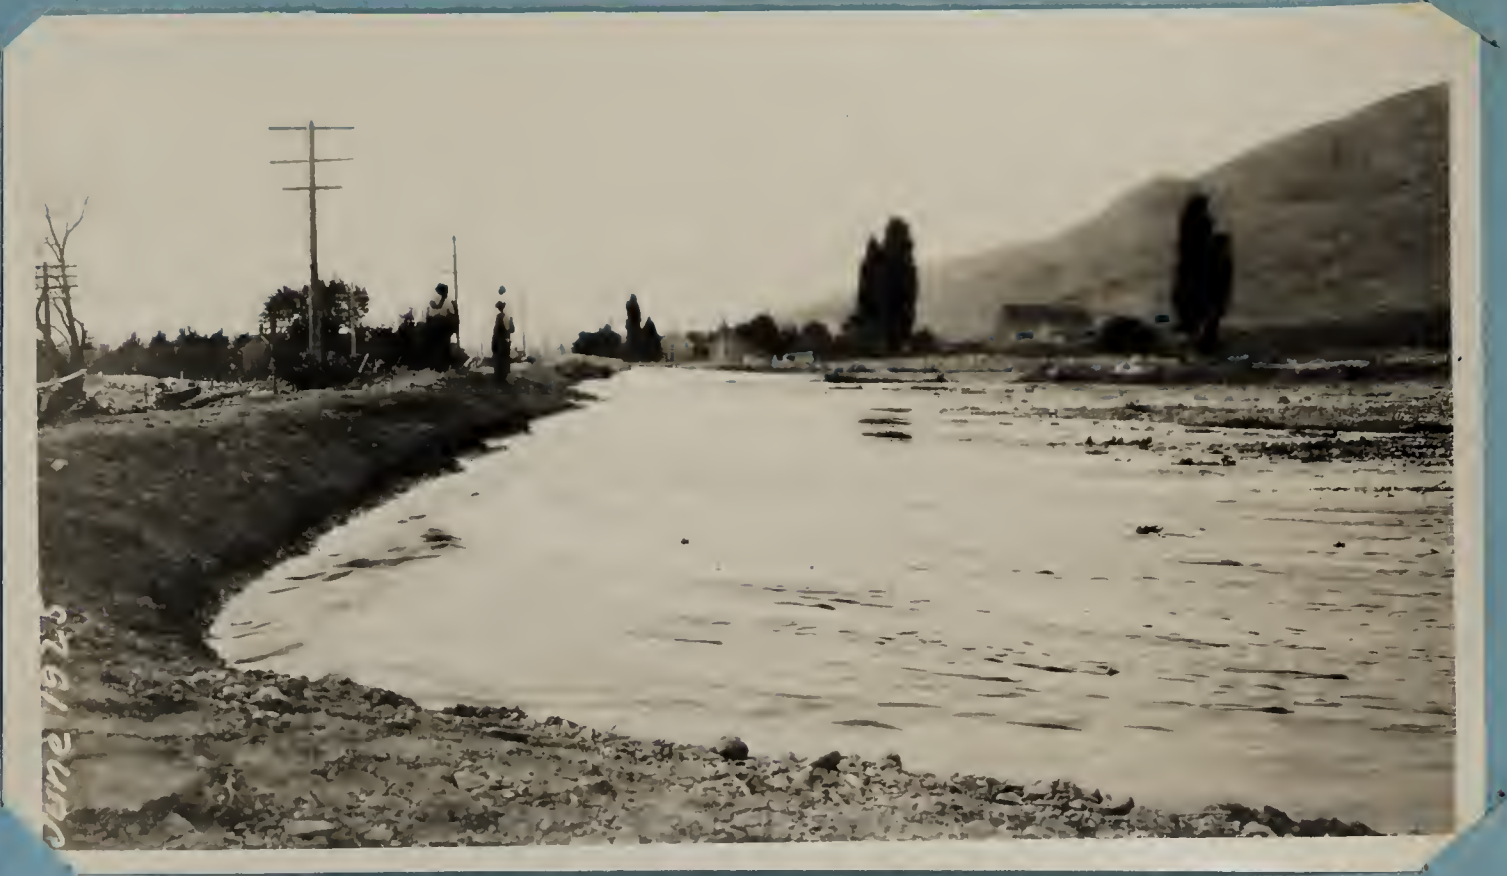
Interior of the New Barrier Basin - June 1925.

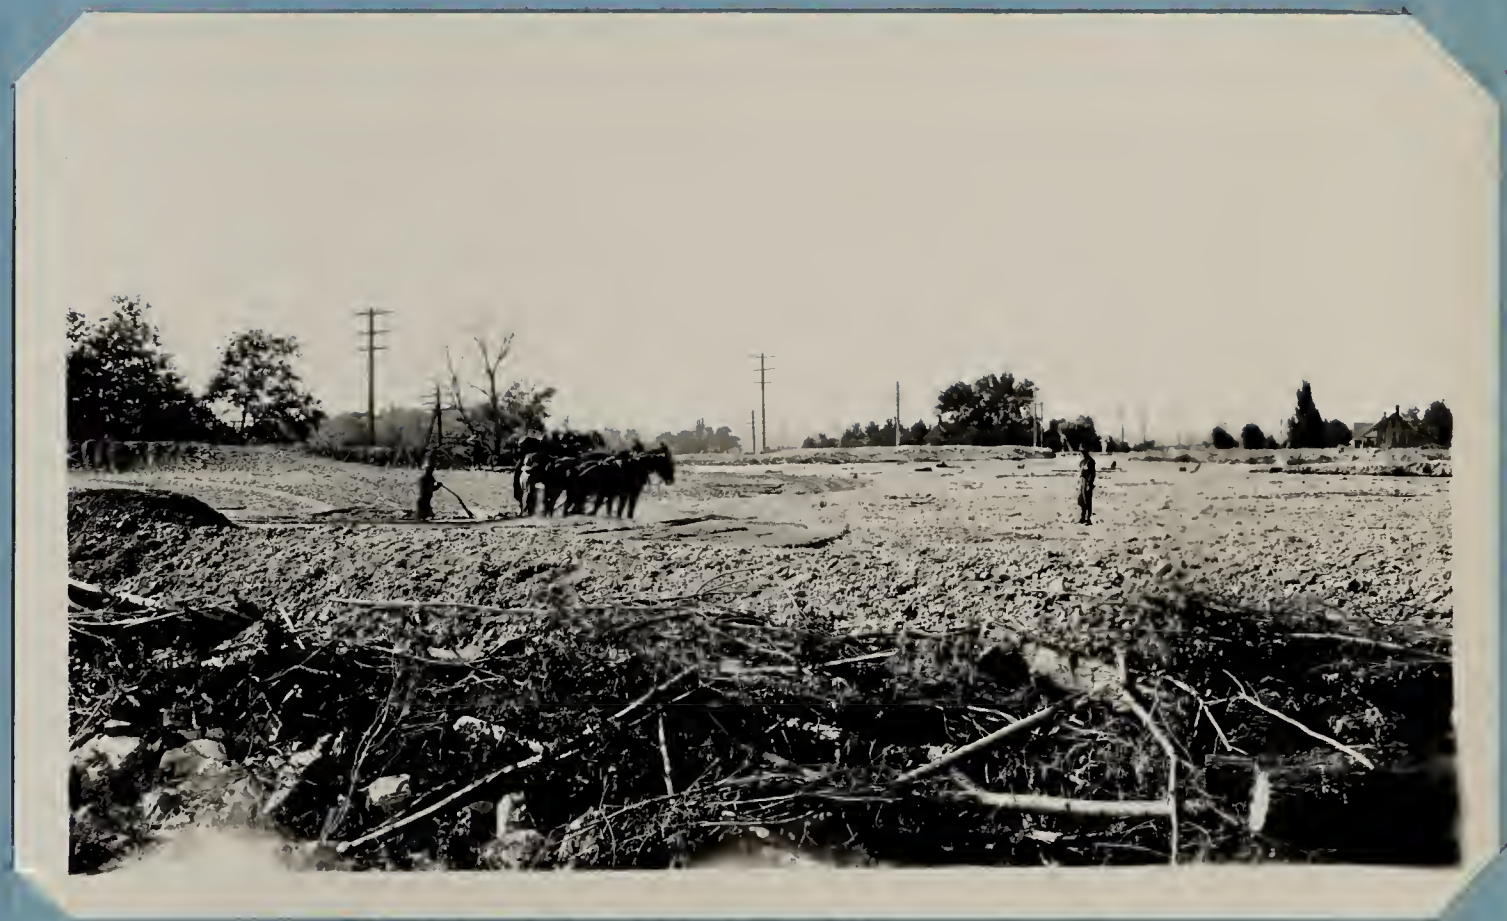
Raising the outer bank still higher- July 1926,  
Just previous to summer flood, see Panoram on  
previous page.

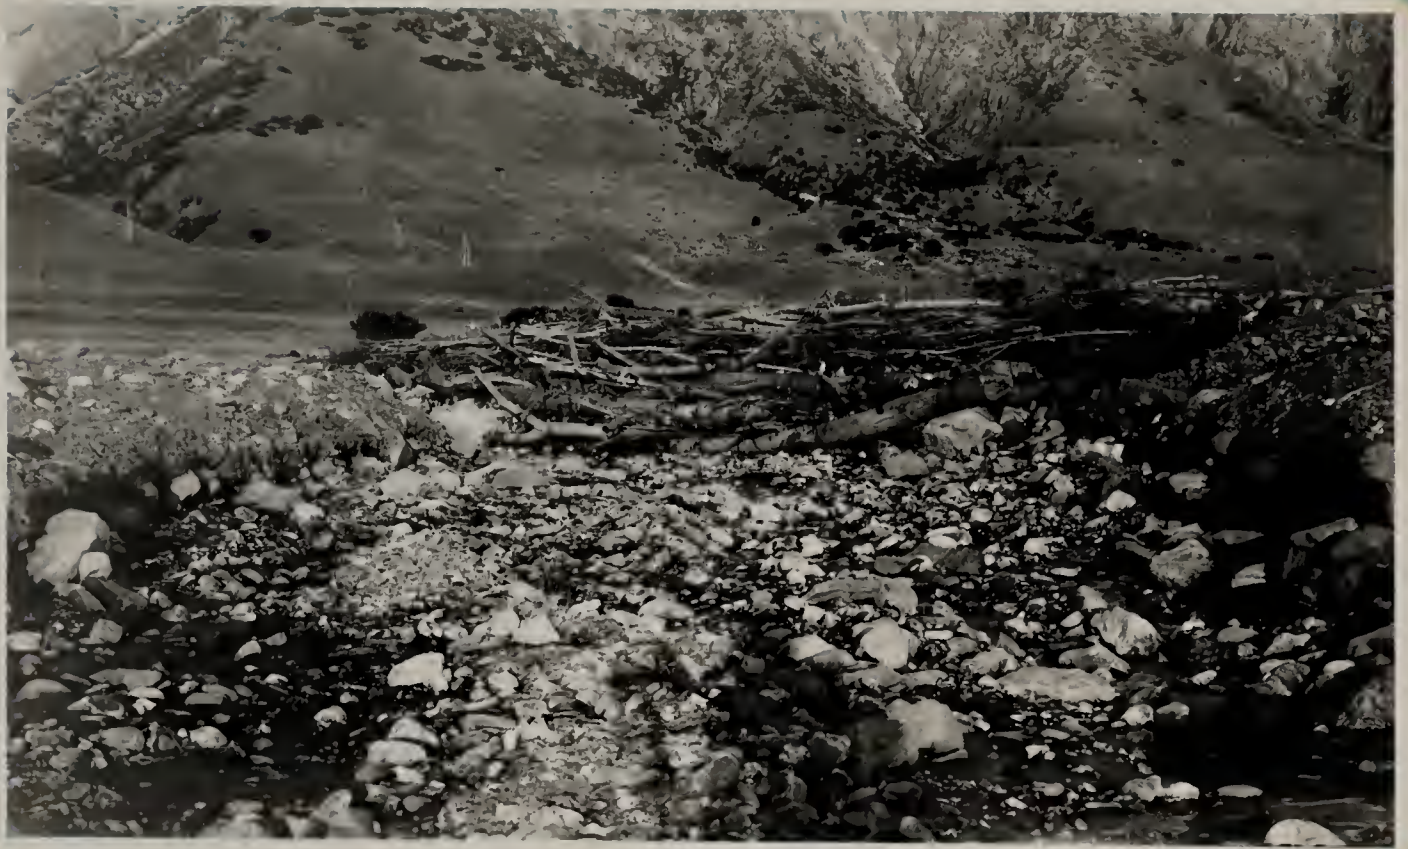
A Beaver dam built by man to divert the stream (Willard Creek) into the Barrier Basin.

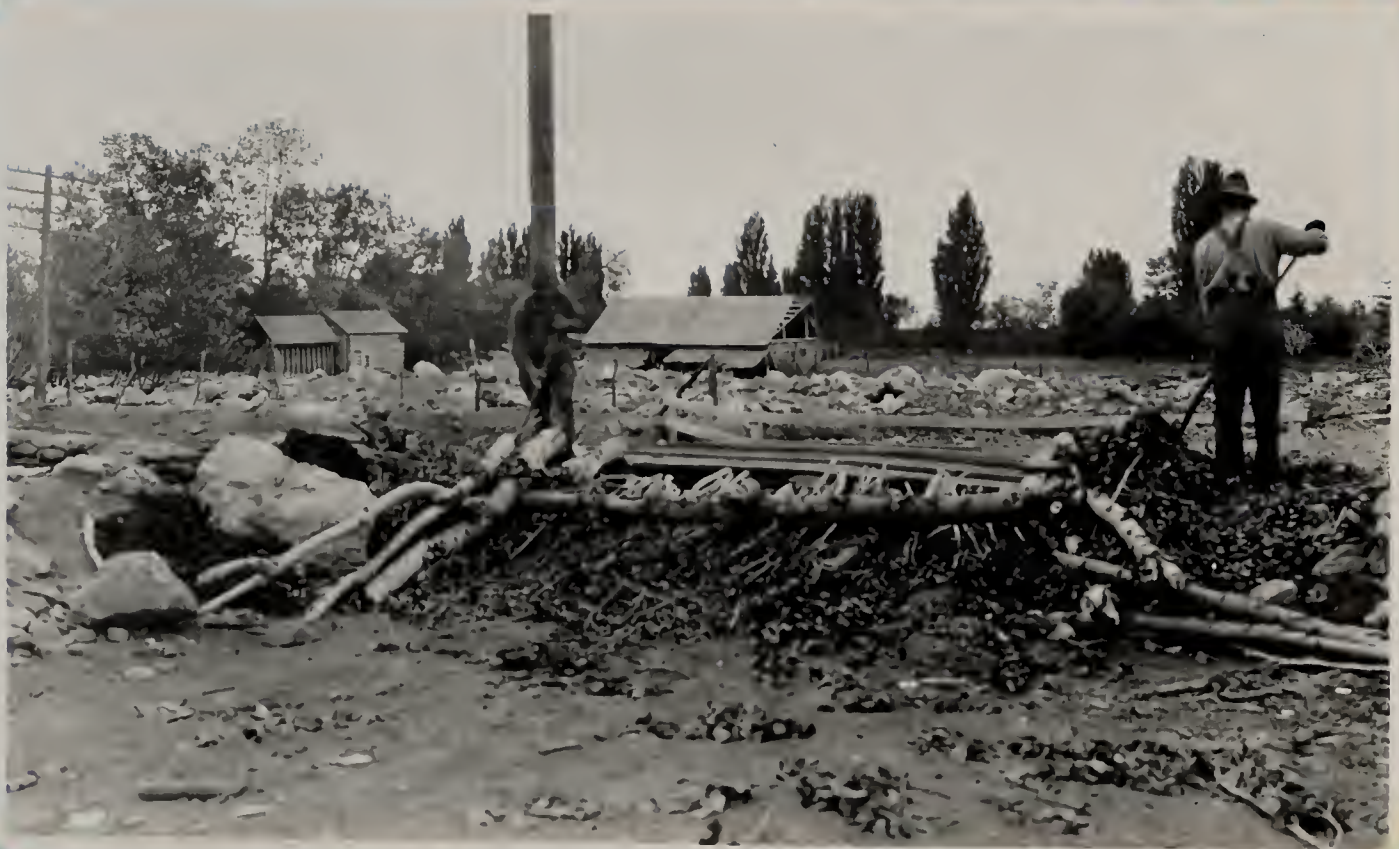
Temporary spillway just above highway crossing.

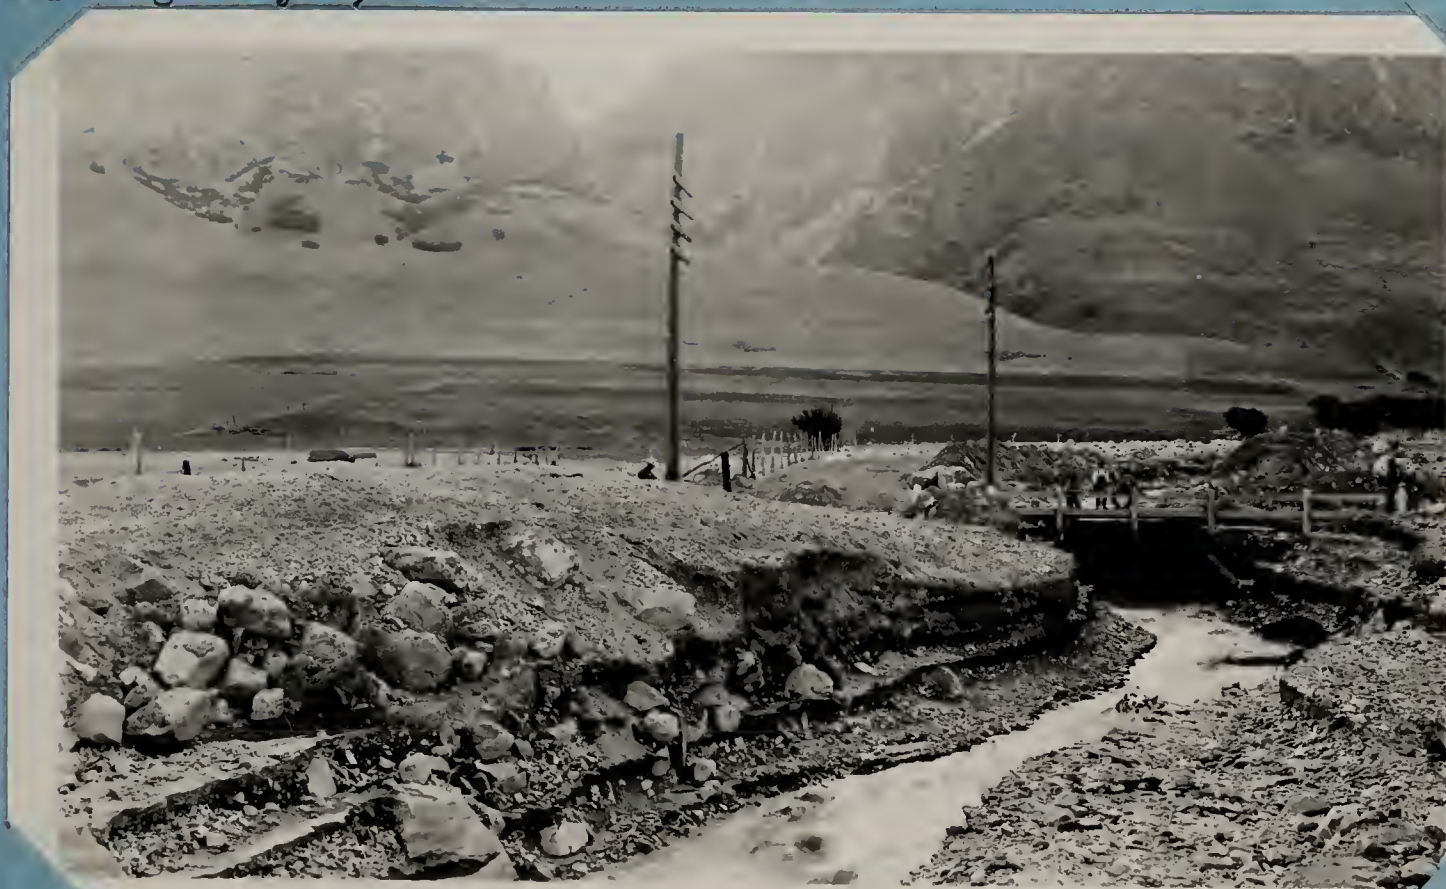
The same 5 days later. When the stream was cleared of its burden, above the hastily improvised barrier, it was free to pick up a new load. Note the successive erosions caused by daily fluctuation in runoff from melting snows. The channel was deepened 18 inches the first night after control, 12 inches the second night during the peak of heavy runoff and so on until a permanent bed was reached 12 feet below highway level.

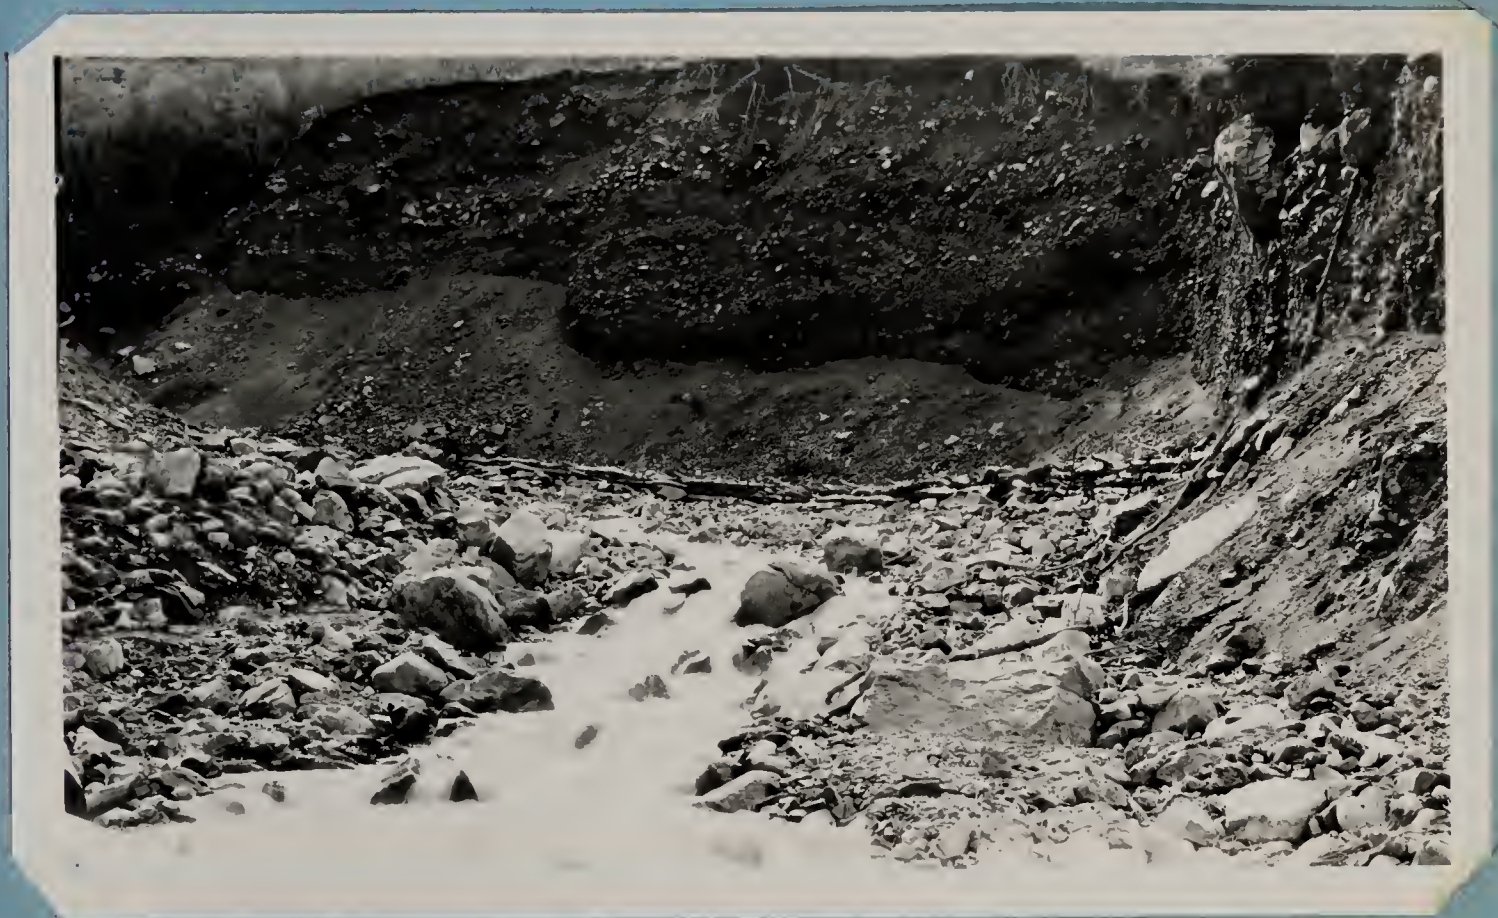
Crib and rock protection in Willard Canyon,  
beneath a 75 foot bank of gravel.

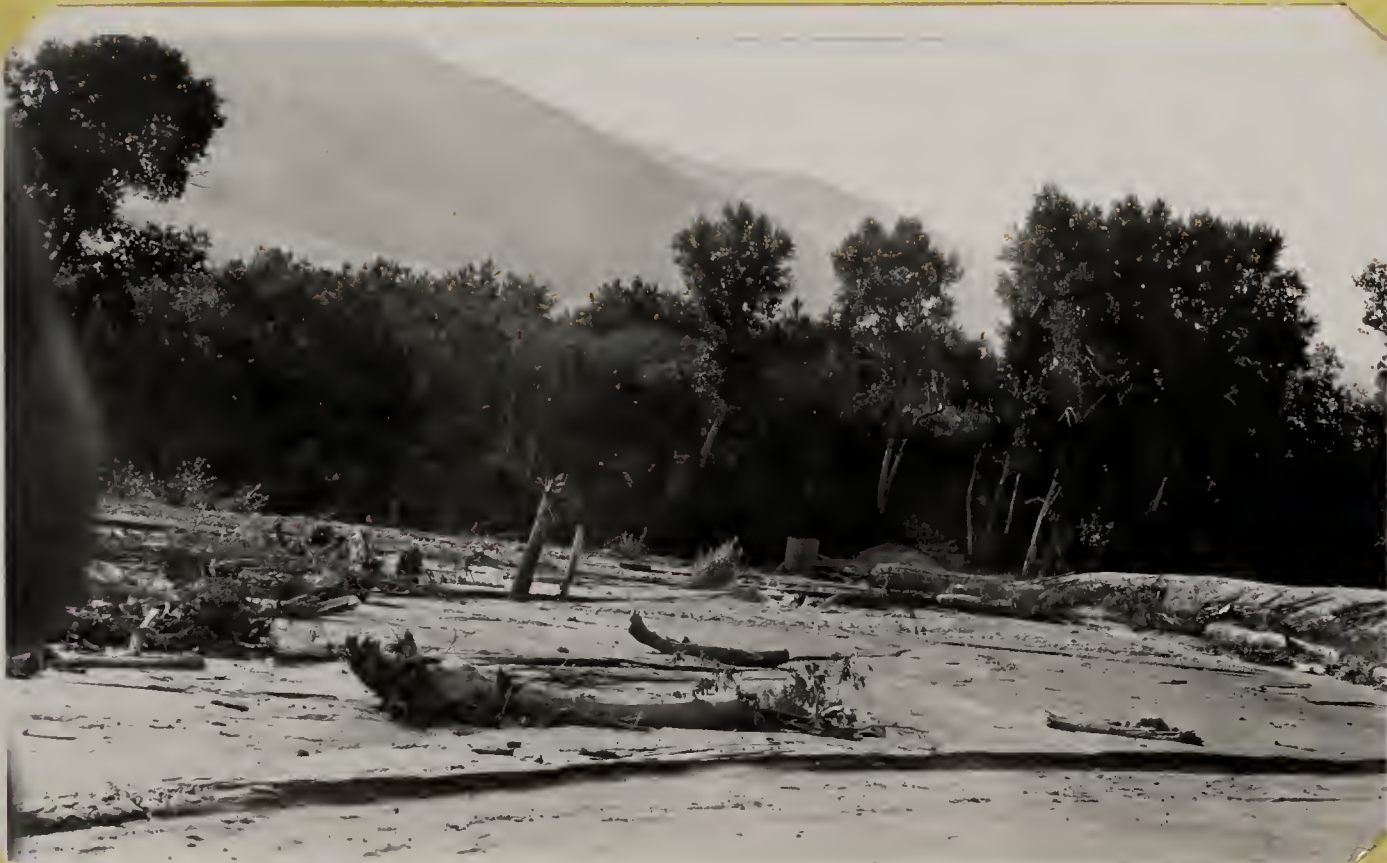
The same after successfully controlling a heavy torrential flood on July 3, 1925.

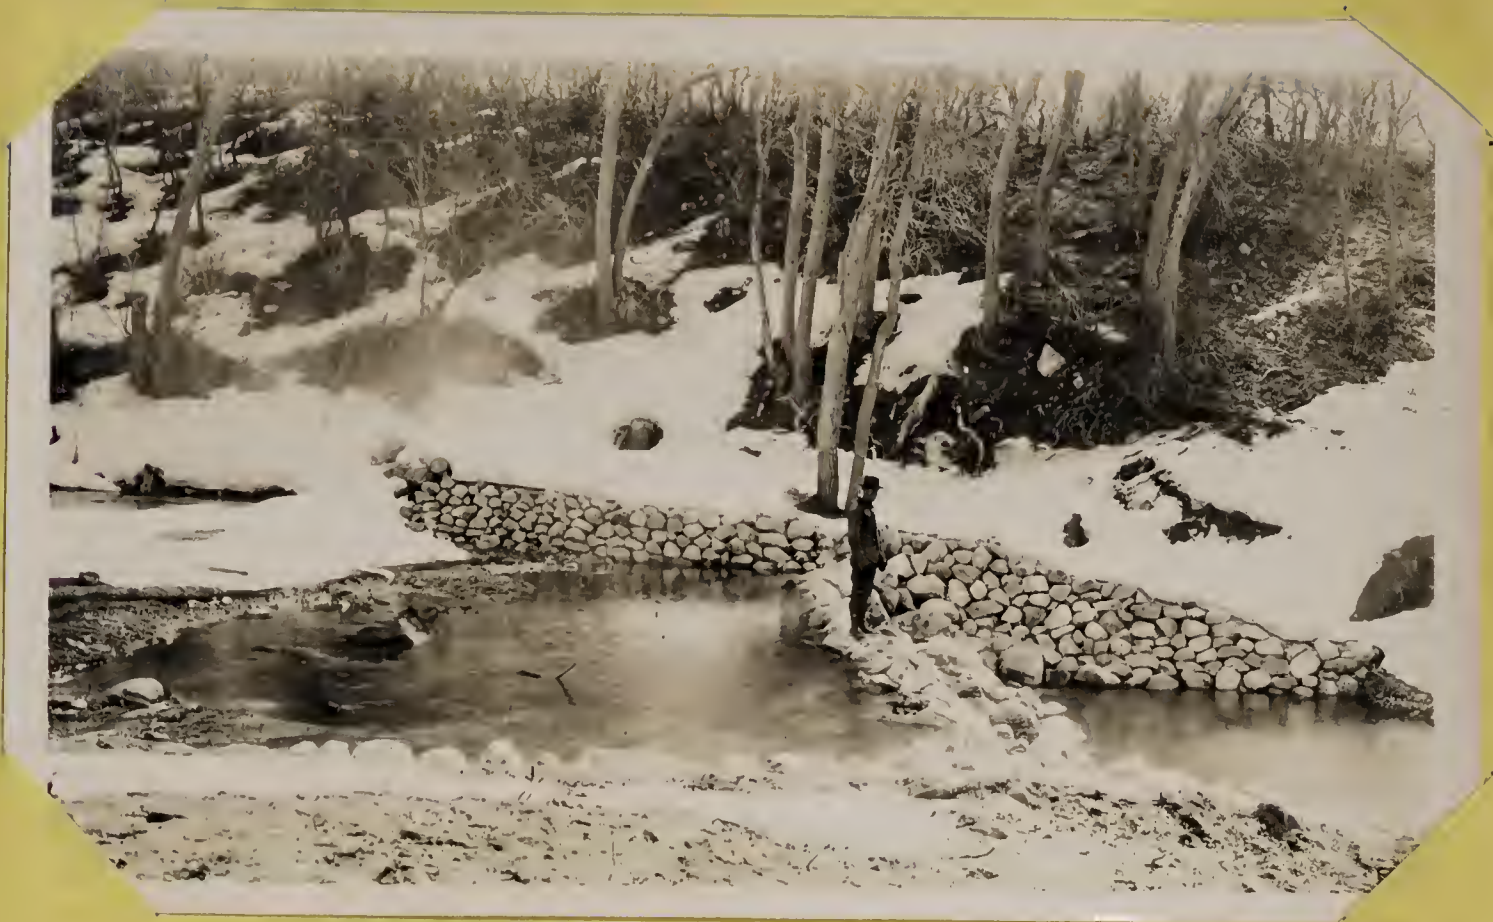
Farmington Spillway at first stage of development.

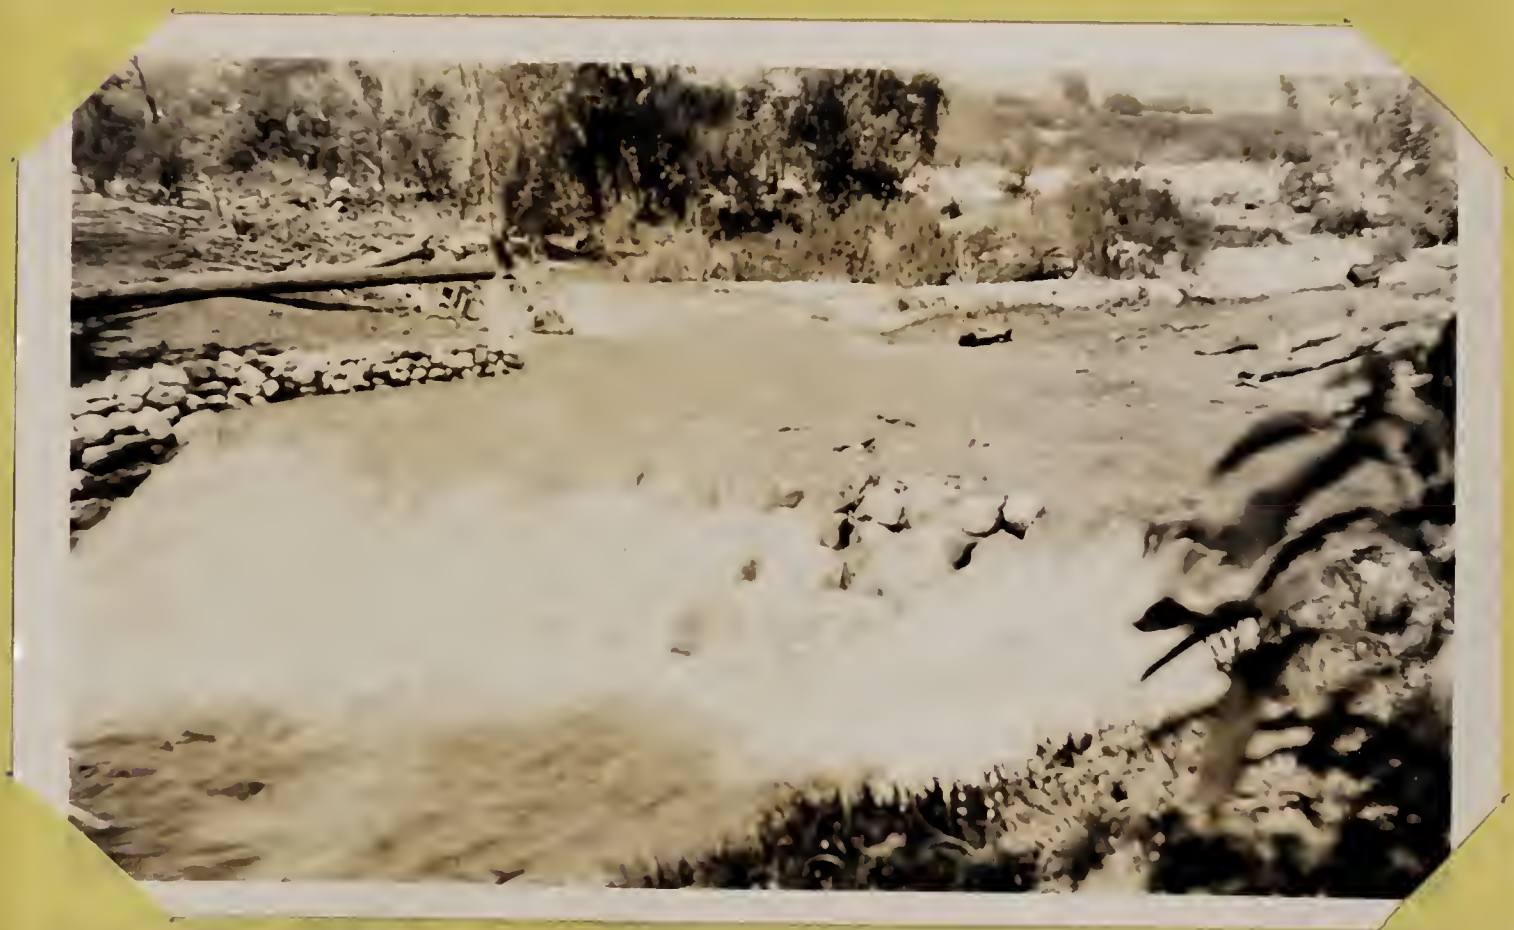
The same during spring runoff in 1925.

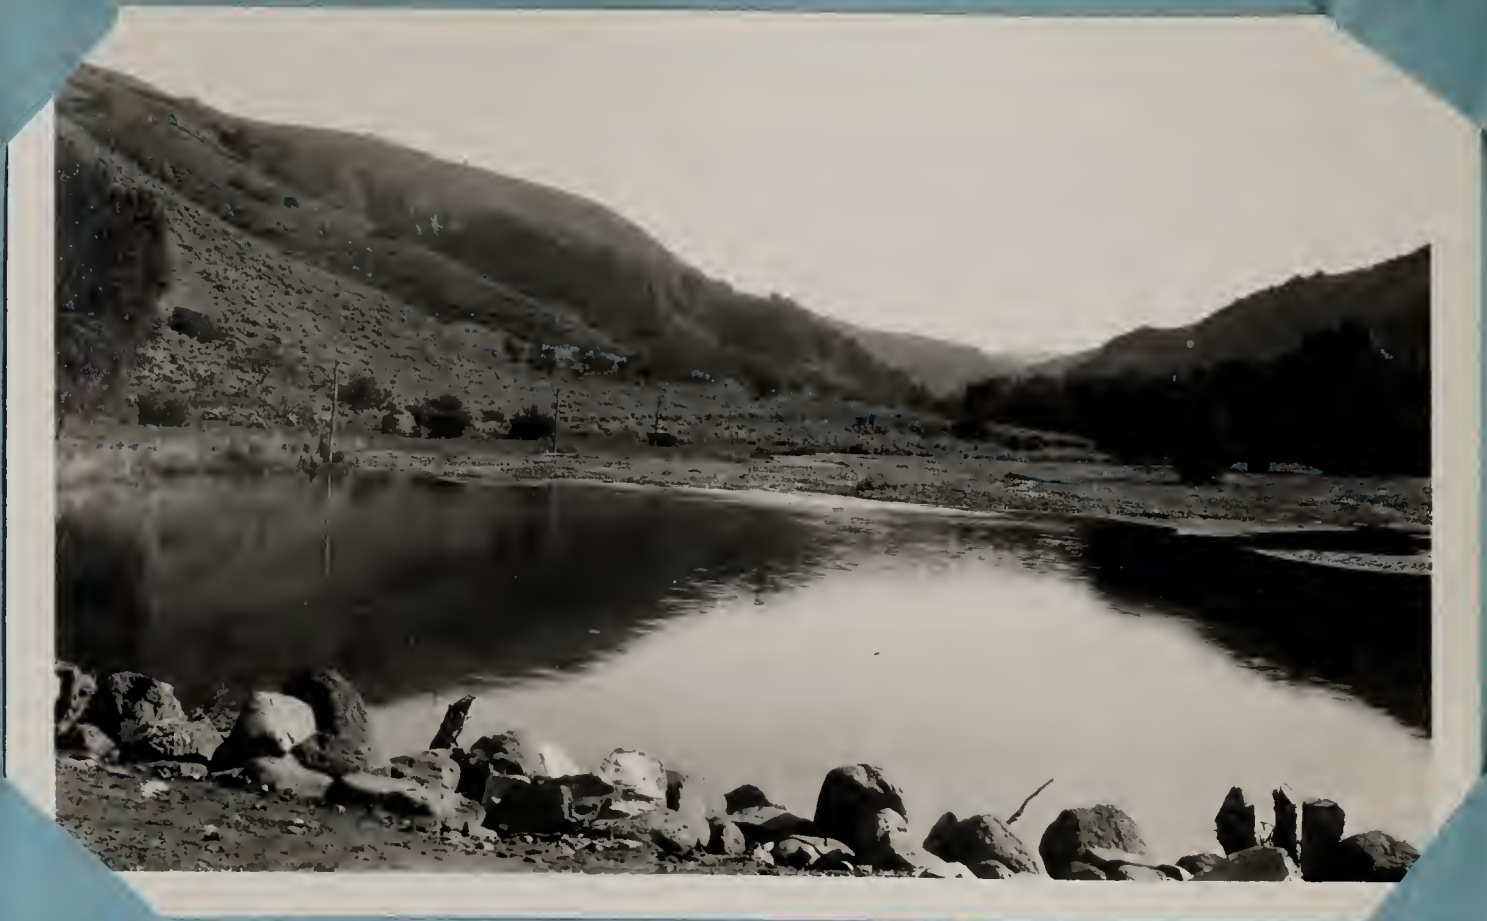
Looking up stream across Salt Creek upper Barrier after it had been in operation two years. Note the immense deposit of gravel above the water line also the extent of the still water pool which did not fill during the first twenty four hours as was predicted by a skeptical water user.

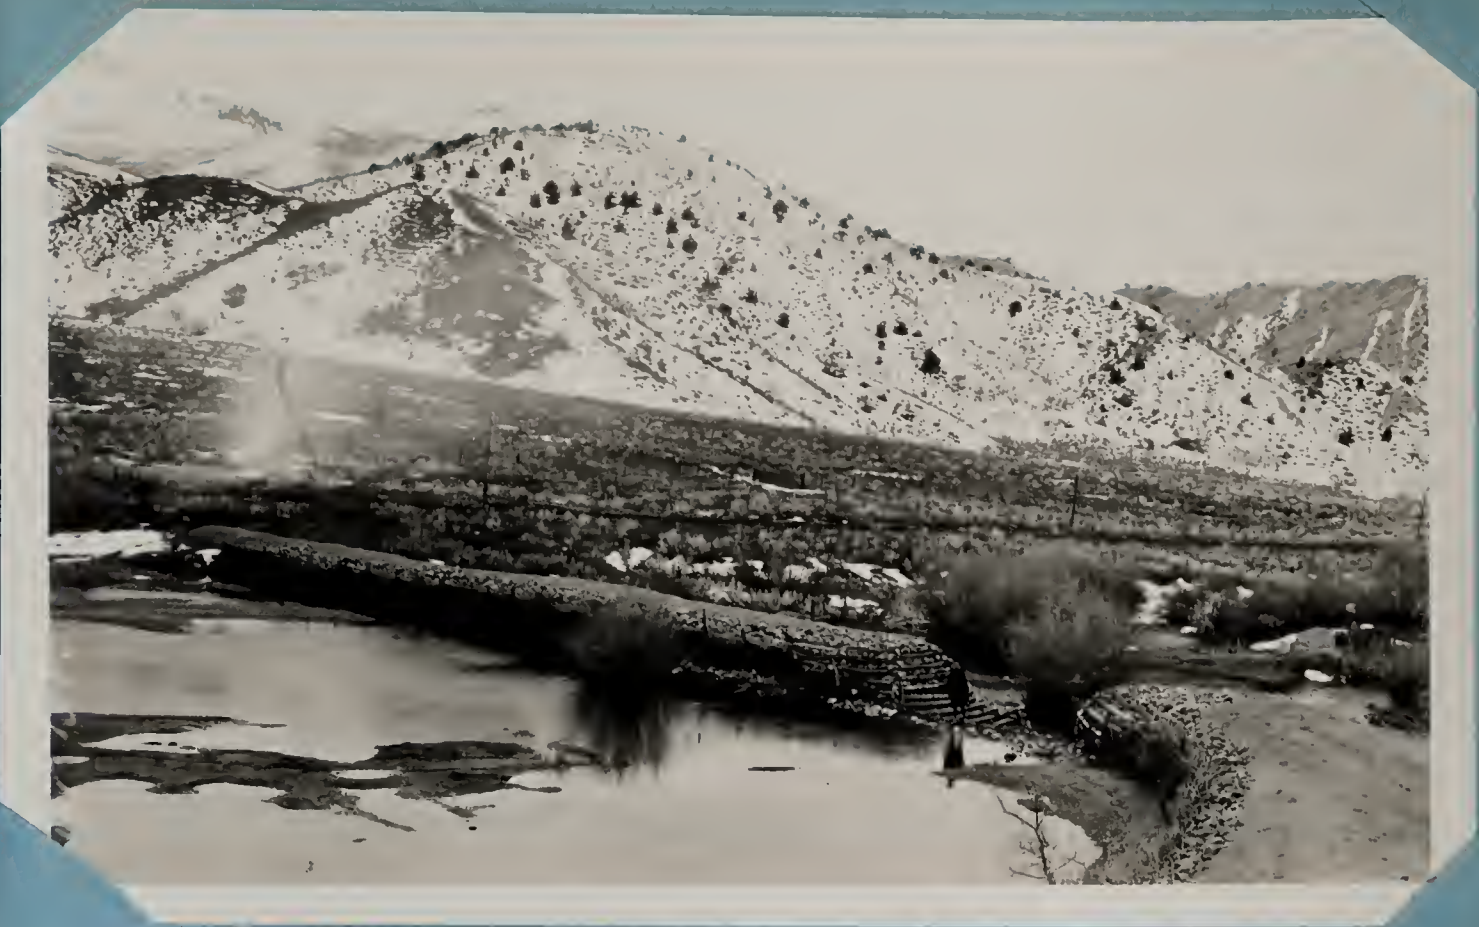
Lower Barrier on Salt Creek above Nephi at the beginning of the third season of operation.

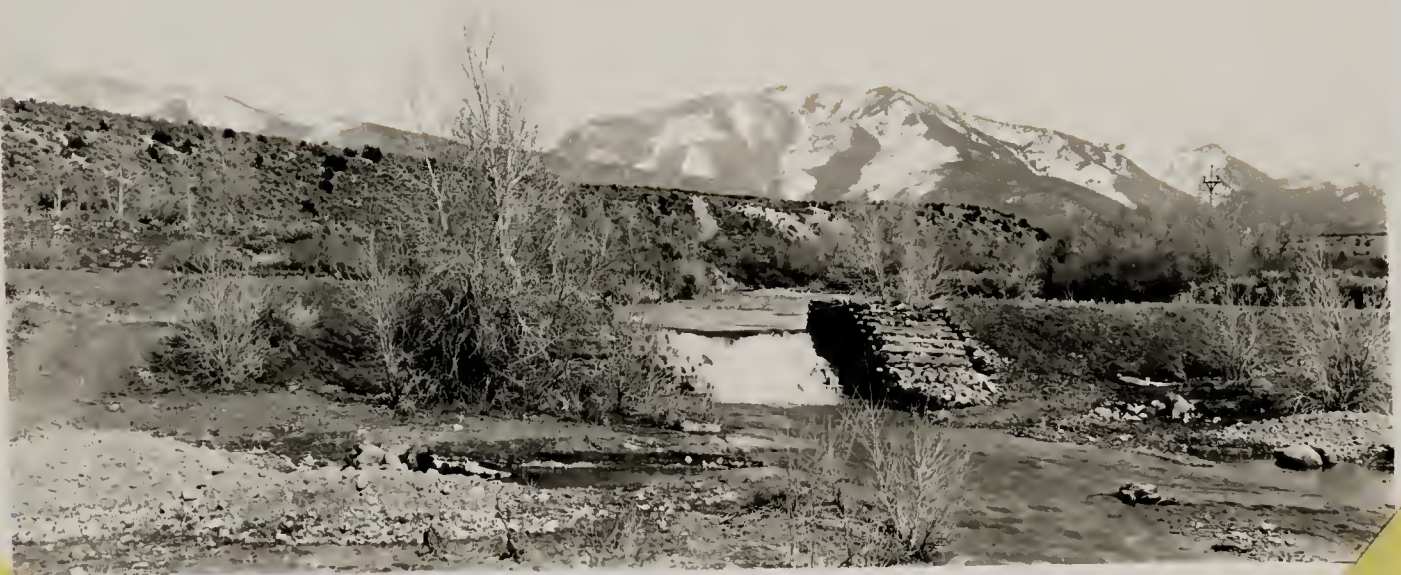
Chalk Creek Barrier and Spillway which for ten years has successfully controlled floods and caused the high water streams to completely unload their burden of gravel which was formerly a menace to successful irrigation.

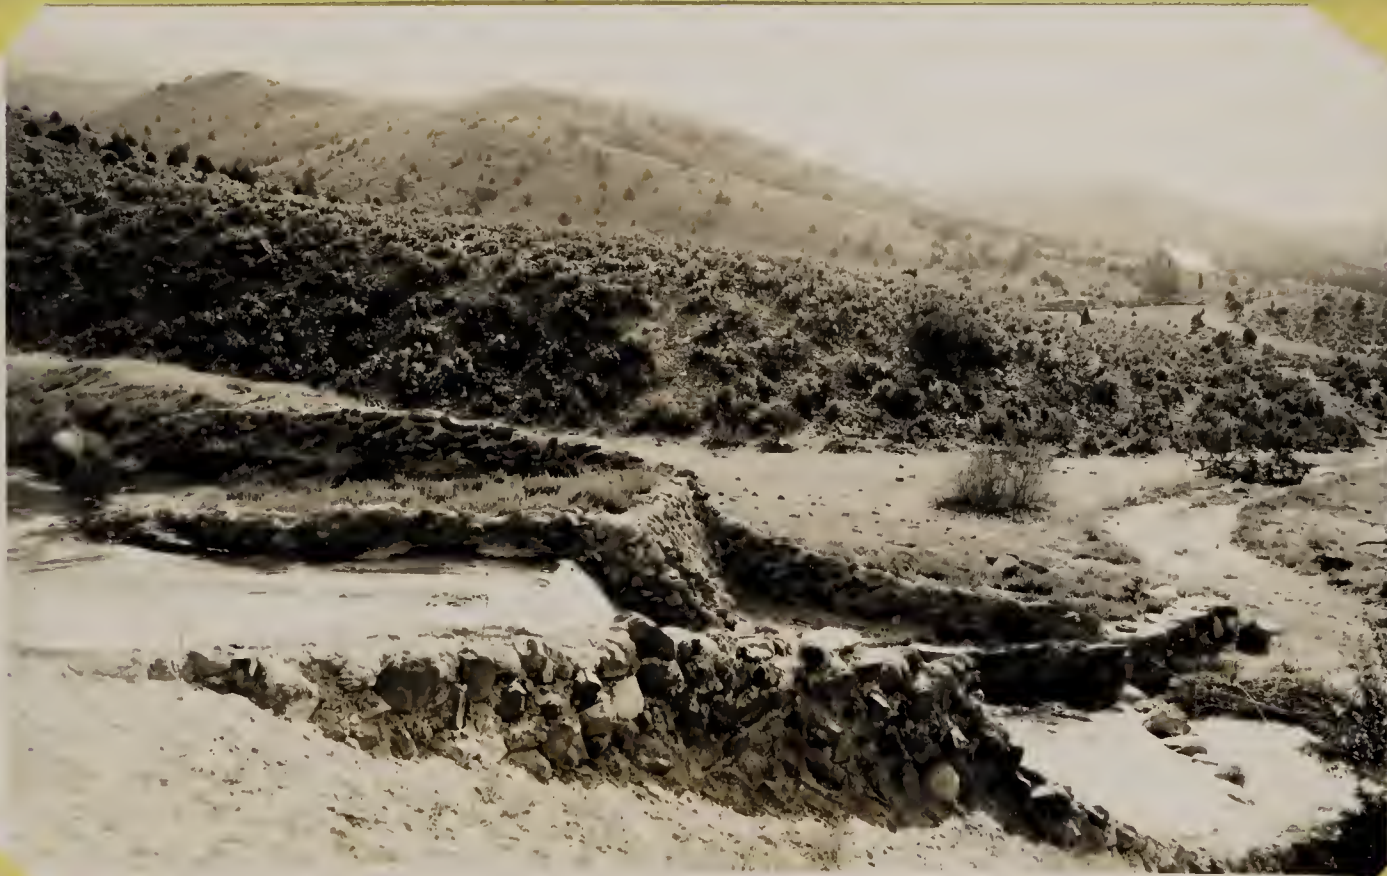
Parowan Barrier Spillway - Note expansion of wings to accomodate excessive floods.

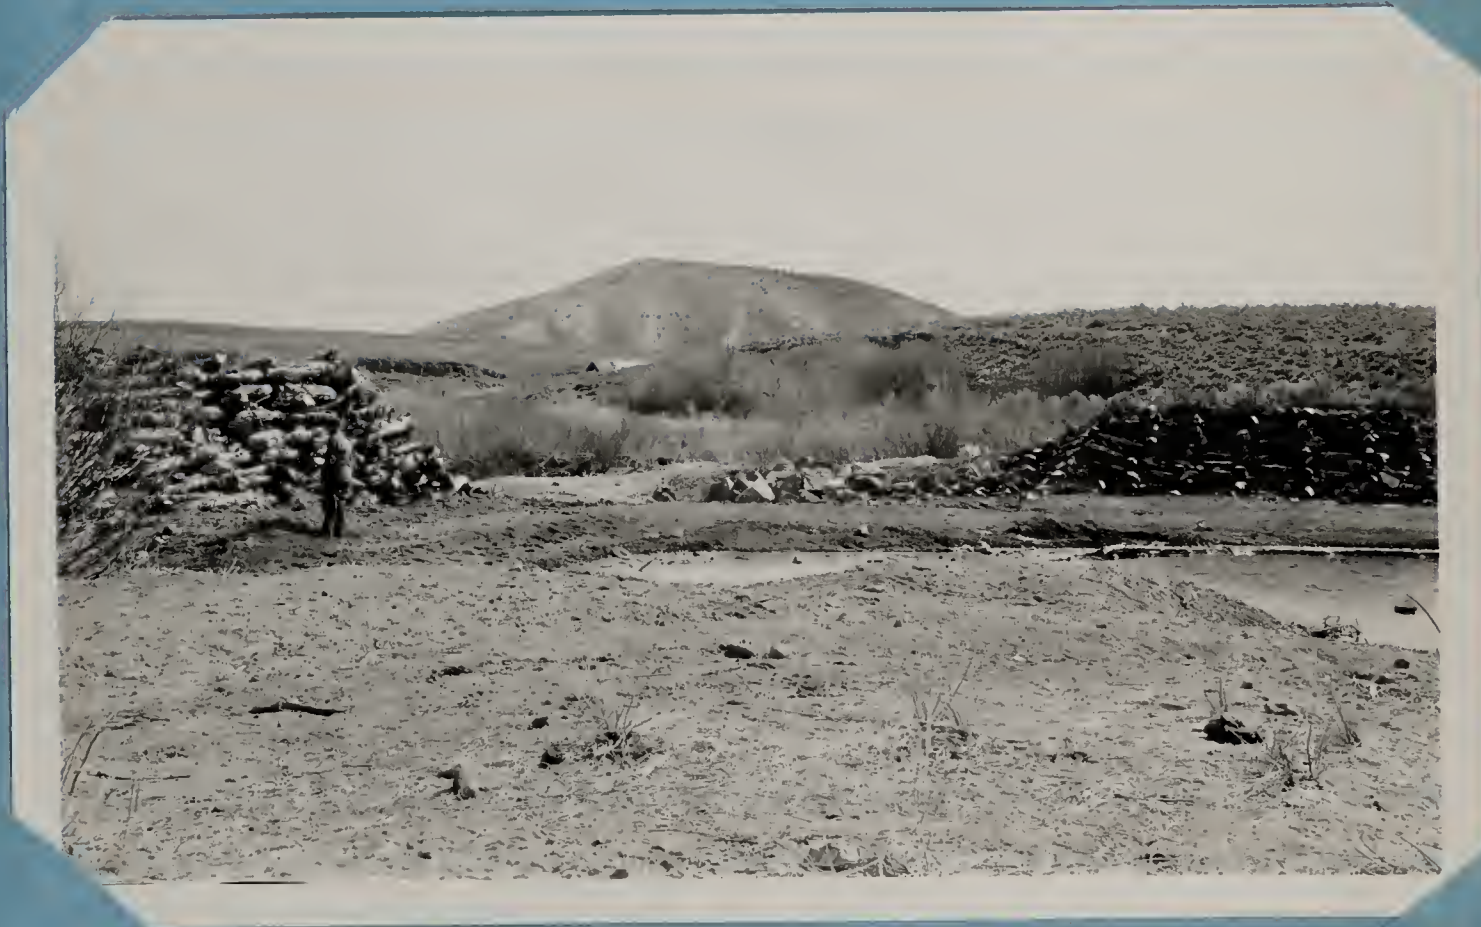
The same looking down stream. This structure made of Juniper timbers cribbed and spiked together and loaded down with dirt and rocks puddled into place.
